From: David Keith <dkeith@anchorqea.com>
Sent: Friday, June 12, 2015 6:45 PM
To: Miller, Gary; Leos, Valmichael; Sanchez, Carlos
Cc: Dave Moreira (dmoreira@wm.com); Phil Slowiak; Wendell Mears; John Verduin; John Laplante; Holly Samaha
Subject: RE: SJRWP-photos of cap liner exposure 6/11/15
Attachments: 11June2015 Harris Co Incident_1535_150612.pdf

Figure 3
 January 2015 Semi-Annual Inspection Survey
 Post TCRA Semi-Annual Inspection (January 2015)
 San Jacinto River Waste Pits Superfund Site

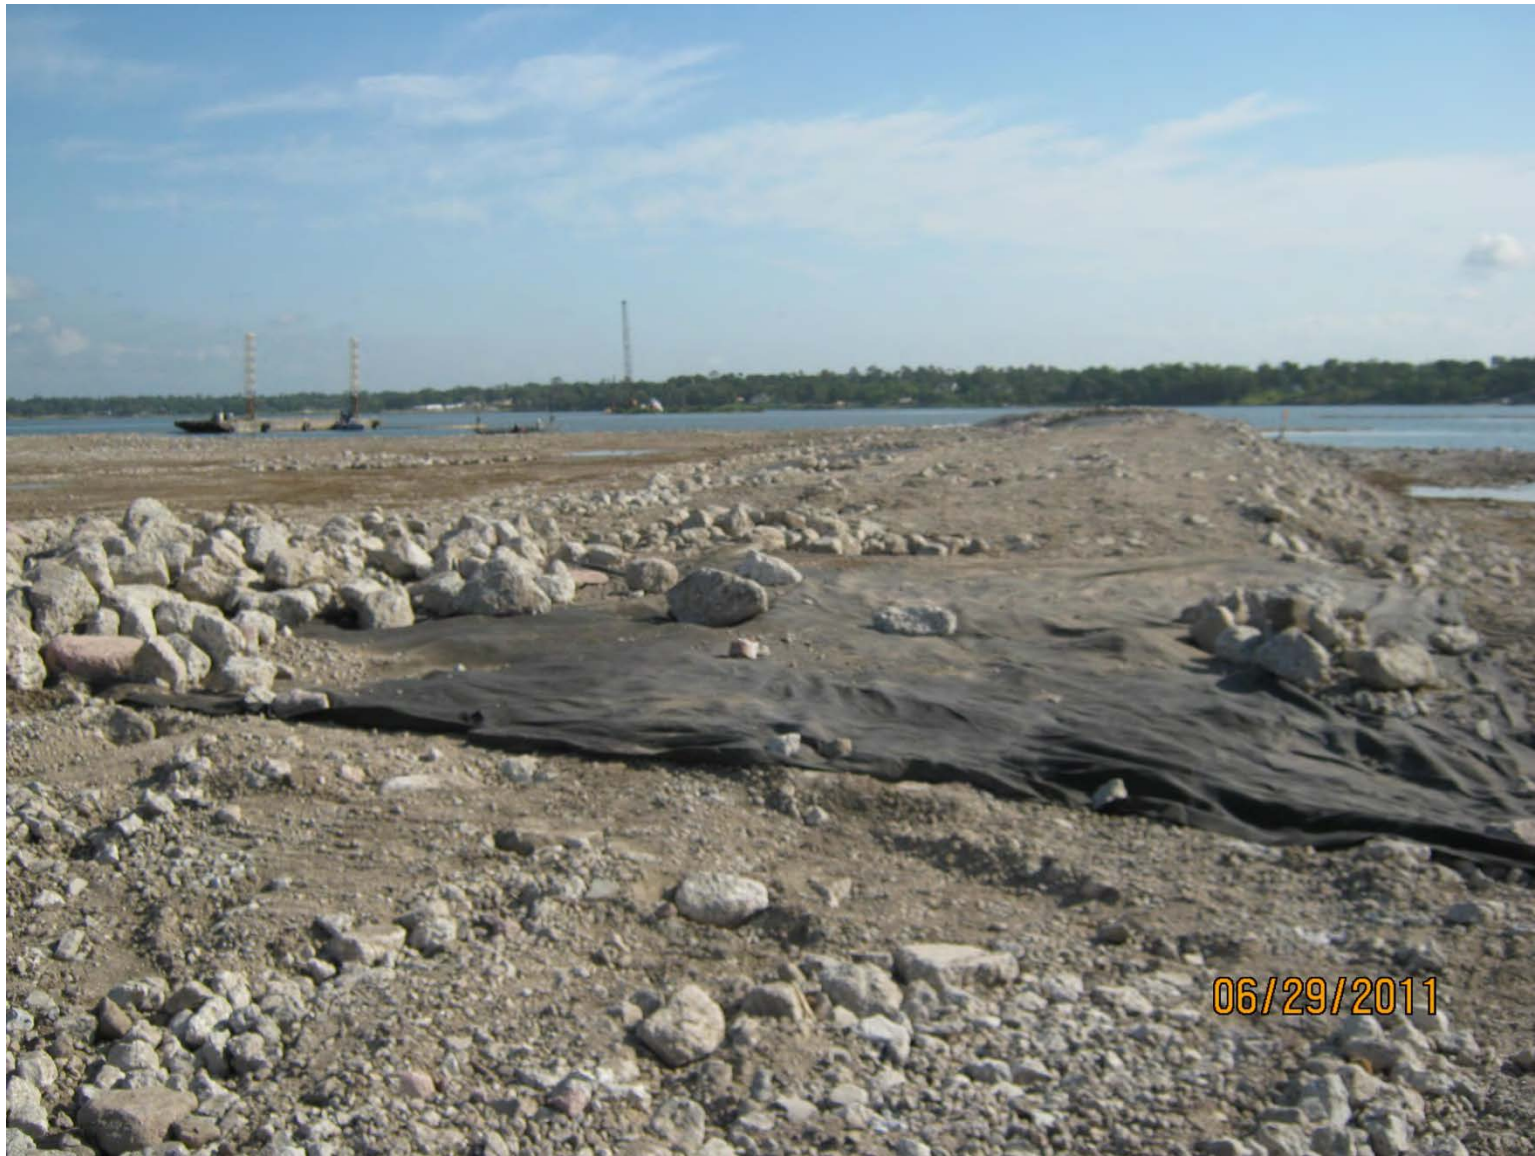
Final layer of geotextile before being covered with last layer of armor stone on the stockpile area. Looking north along the central berm. Note armor stone under geotextile fabric.

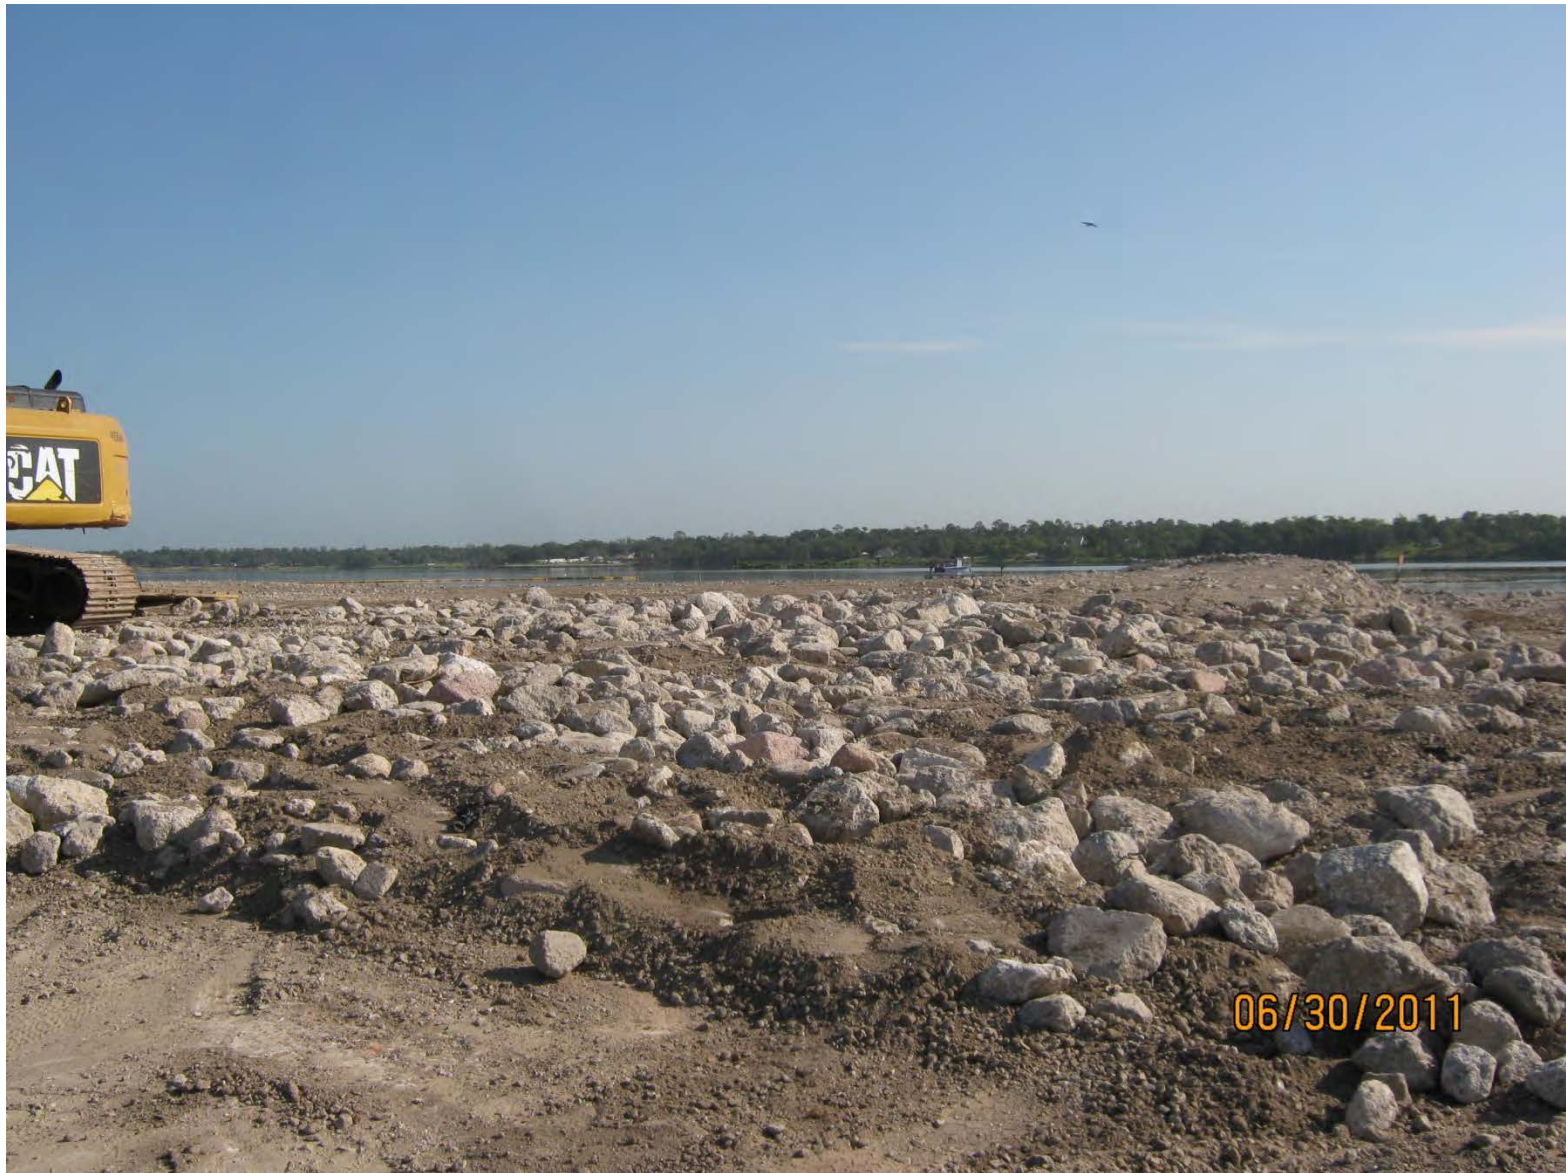
Final layer of armor stone placed over layer of geotextile. Looking north along central berm. Note reddish colored processed concrete aggregate.

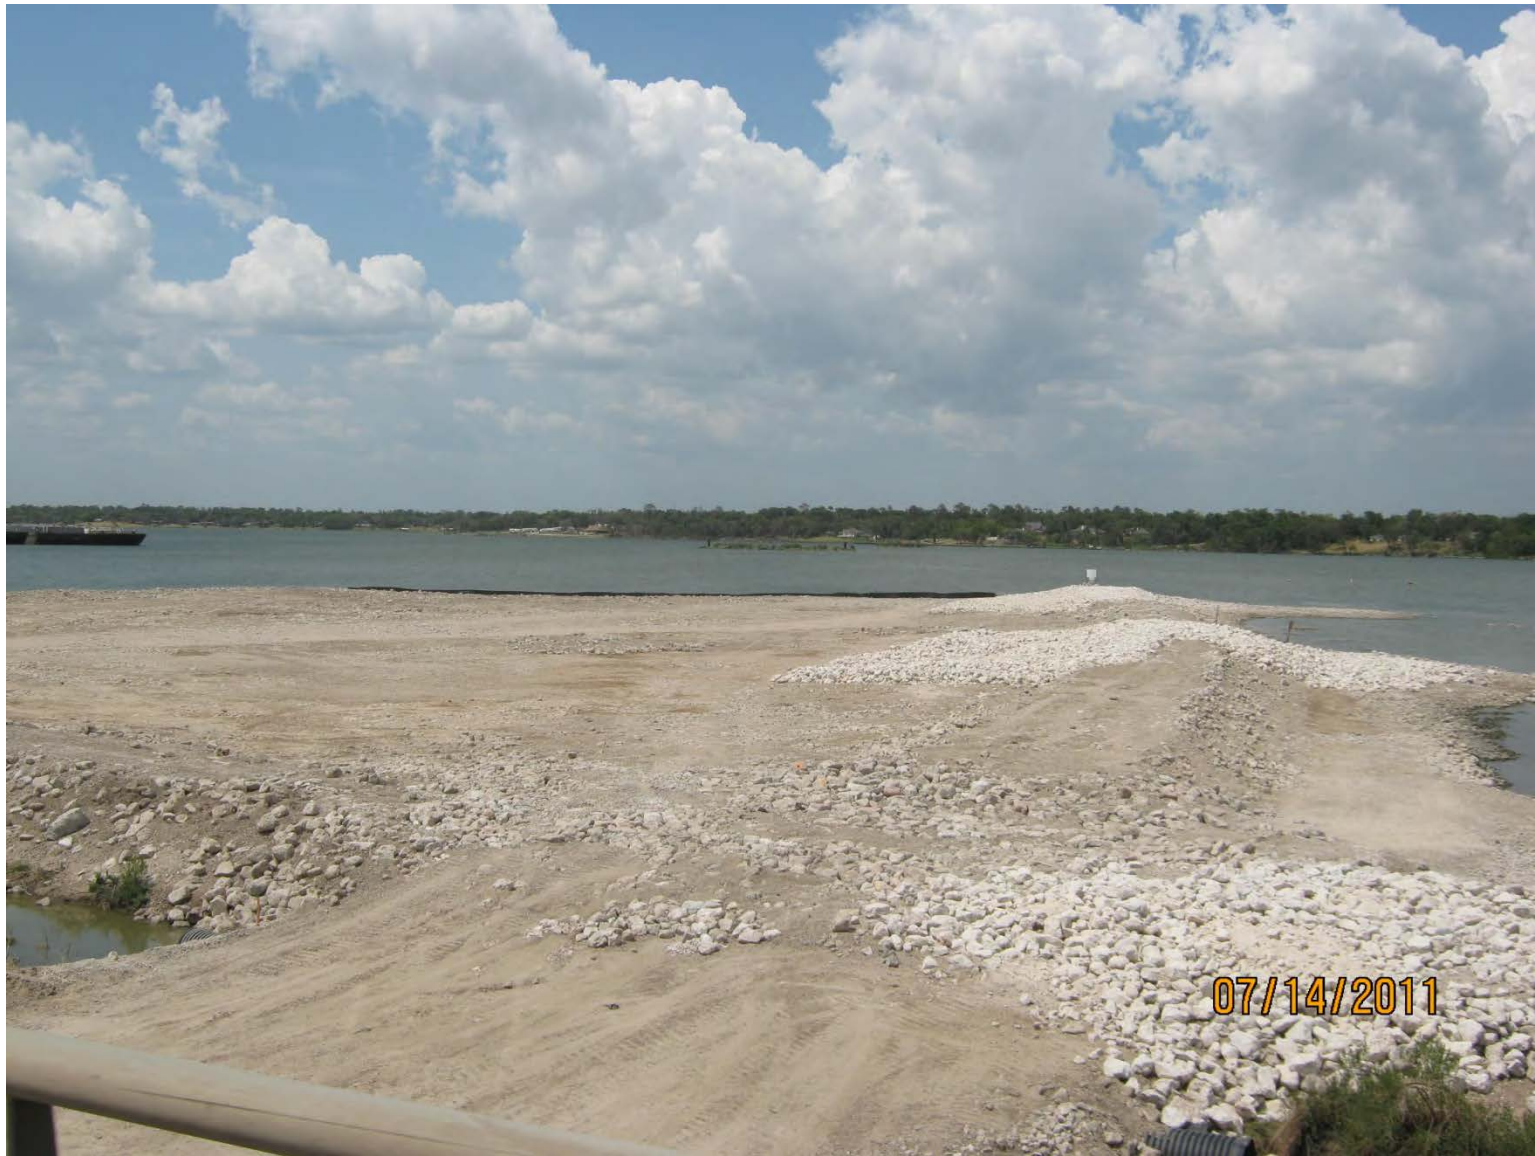
Project completion photo from I-10 Bridge. Note reddish colored processed concrete aggregates in the stockpile area.

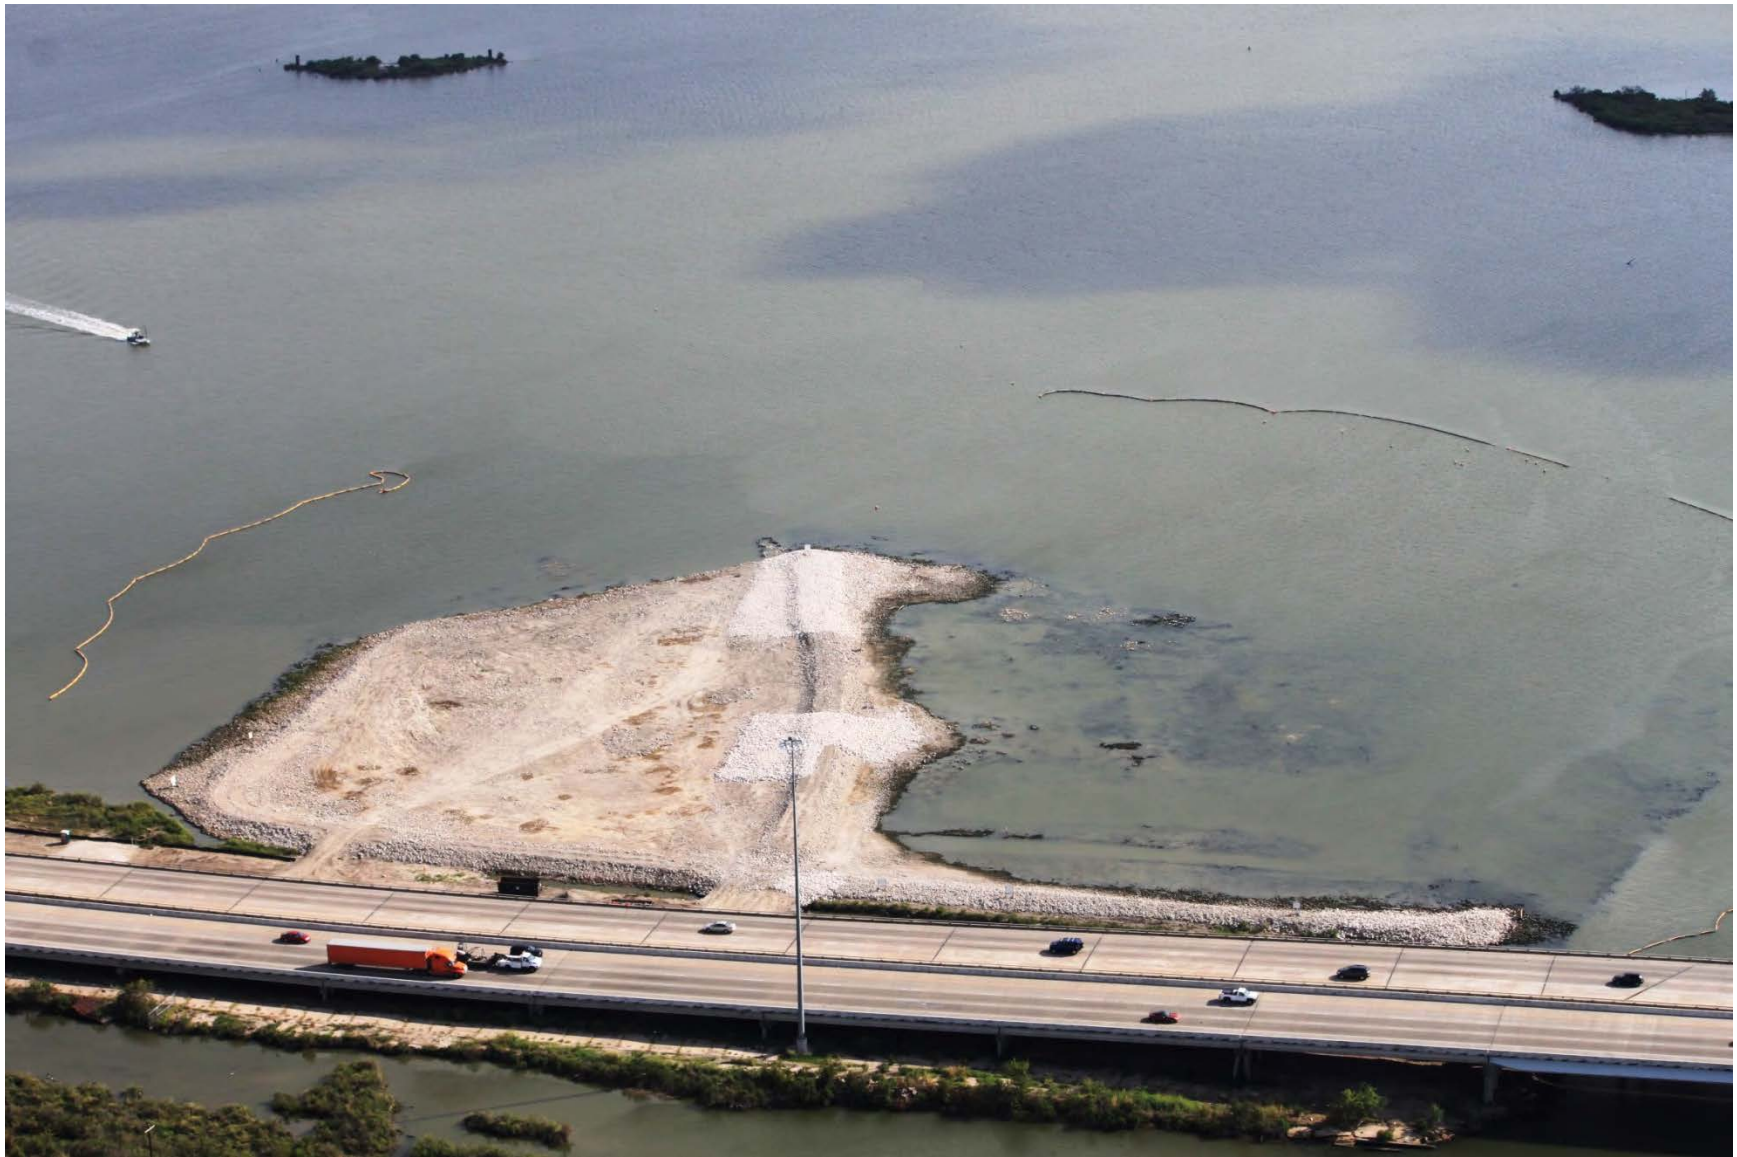
Project Completion Photo dated July 14, 2011 in the photo logs.

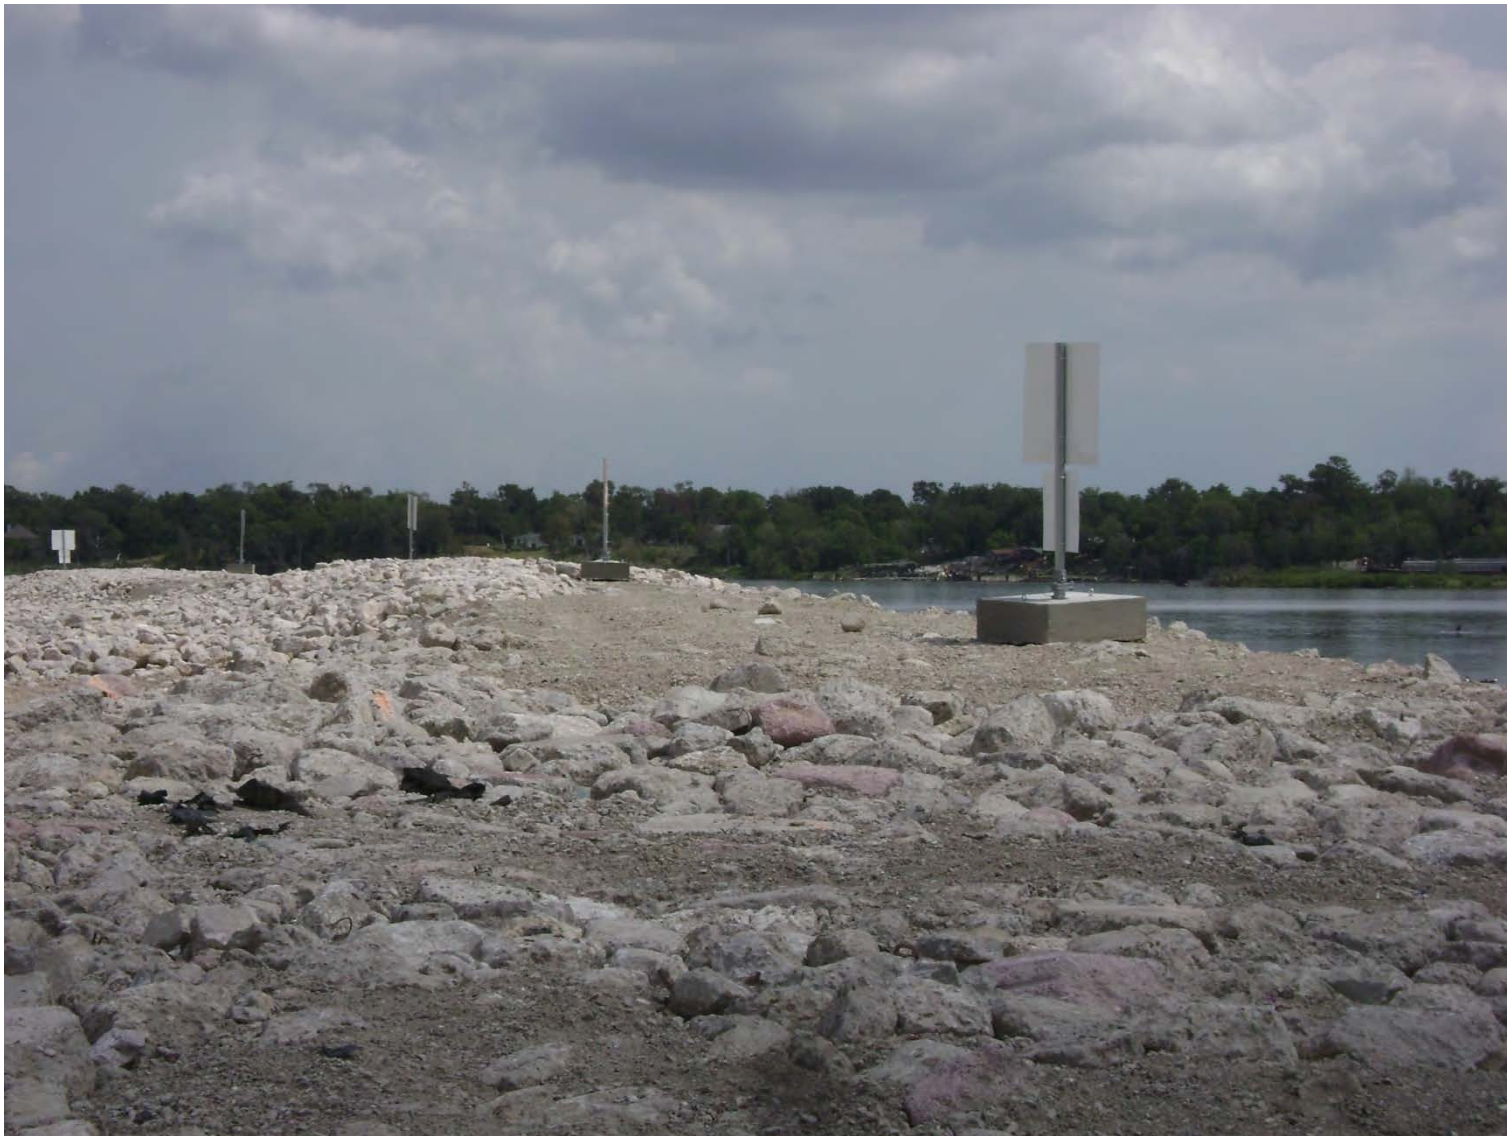
Project completion photo dated July 28, 2011 in the photo log. Note signage and reddish colored processed concrete aggregate along central berm with remnant geotextile from multiple laps for the 12 ounce geotextile underlayer, geomembrane, 16 ounce cushion layer and final layer of geotextile and armor stone.

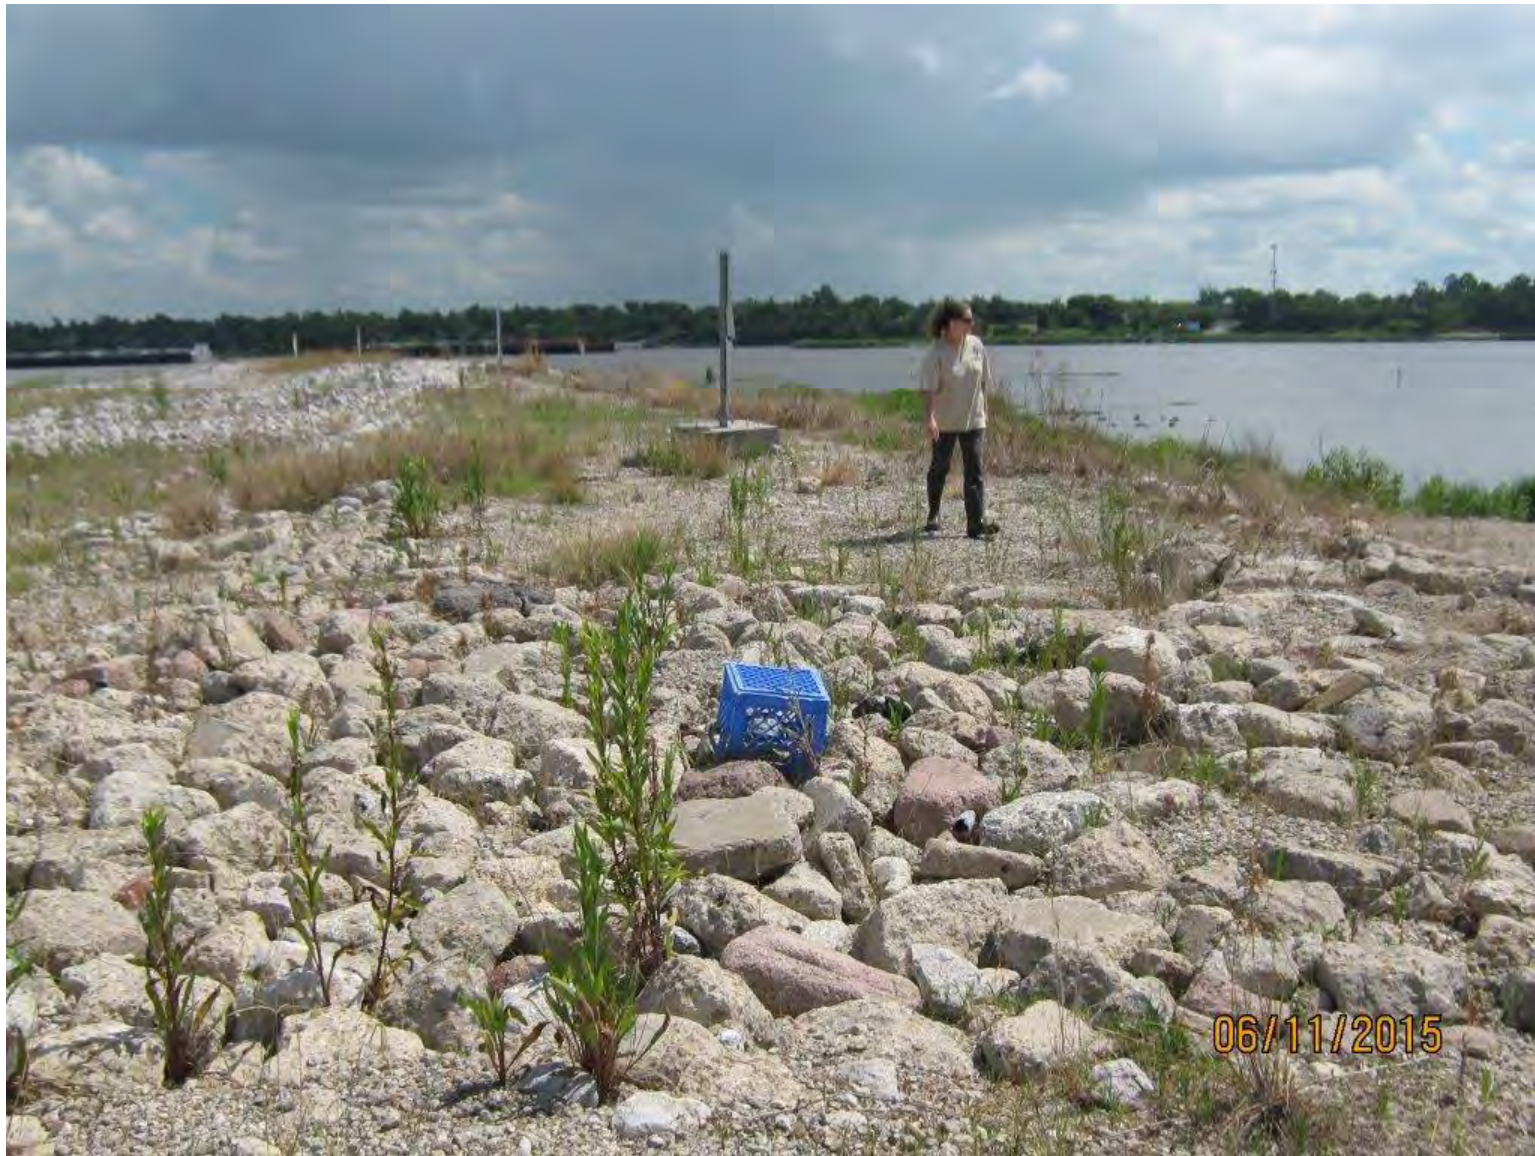
Project Photo dated June 11, 2015. Note signage along central berm and reddish colored processed concrete aggregate.

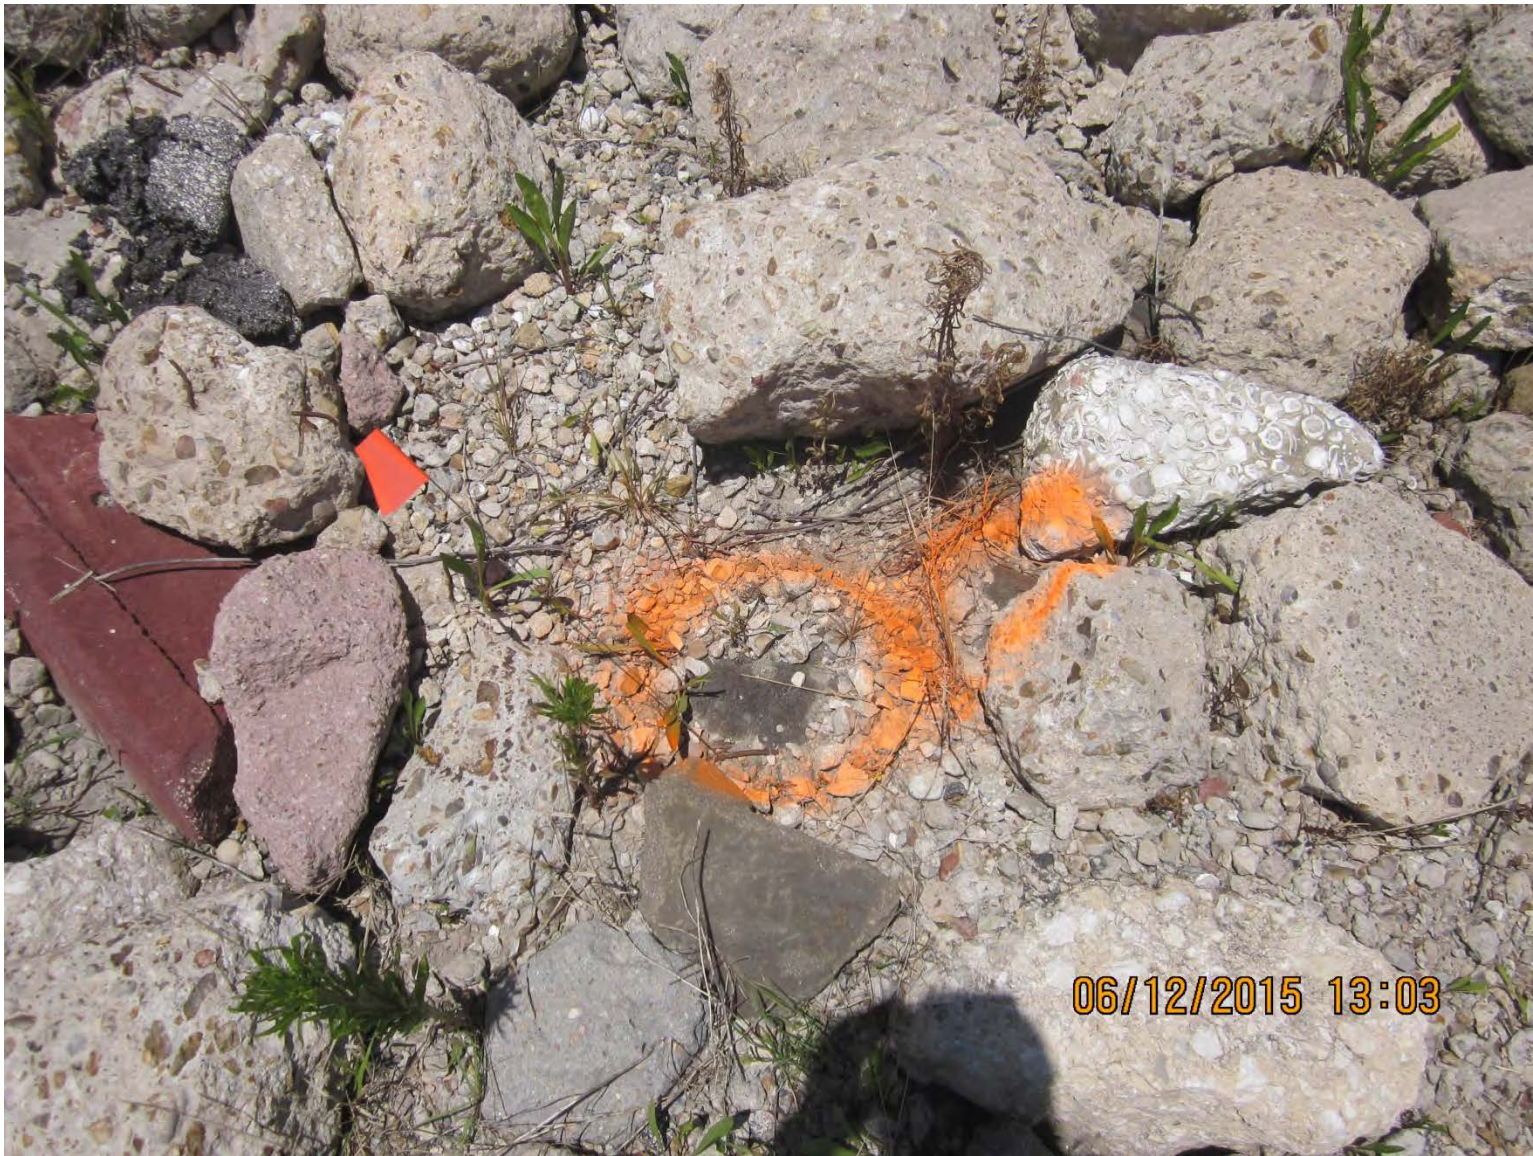
The attached PDF file shows the area of concern and a sequence of construction photos with captions documenting the installation of the different geotextile layers and armor rock. What Mr. Allen observed was small patches of the final layer of geotextile that is underlain by at least two layers of armor rock, additional layers of geotextile, and a layer of geomembrane.

Photo of expose 3rd layer of geotextile atop the central berm stockpile area. Metal rod used to ping rock underneath.
